# Technical Service Bulletin

No.LTB00191  
25 November 2008

**Subject/Concern:** Liftgate Latch Diagnostics

**Models:**  
Discovery 3 / LR3 | VIN-range: 000001 Onwards

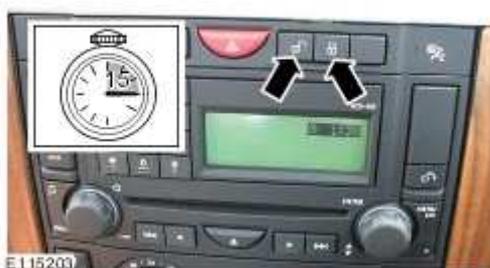
- 1 . Override Liftgate.

Problem	Check/Cause	Action
Liftgate fails to open and actuator can not be heard when external release is pressed.	Can the liftgate be opened using a manual override?	To manually override the liftgate, press and hold both the lock and unlock buttons on the dash for 15 seconds (see step 1 - E115203).
		If the manual override is successful but the external release button is not functioning, replace the exterior handle assembly.
Liftgate fails to open and manual override is unsuccessful.	Remove liftgate interior trim in order to access and remove the latch and actuator.	Using a suitable knife, gasket scraper or similar tools, prise the lower liftgate carpet from under the top trim of the liftgate. This is the trim piece that includes the button for the lower liftgate. This location is the soft spot where you can pull the carpet trim out from the top cover. It's located approximately

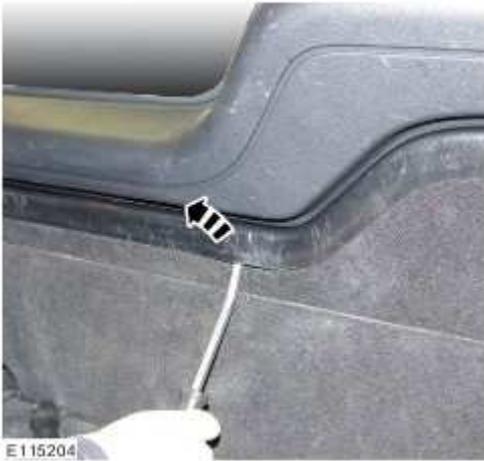
2 . Release Trim.

in the centre of the passenger side of the vehicle (see step 2 - E115204) (Care must be taken to ensure that the lower liftgate upper moulding is not damaged).
		Position the carpet trim away from the liftgate to gain access to the latch, actuator and the water shedder (see step 3 - E115205).
		Pull the lower liftgate trim cover open about 2 to 3 inches or make enough room for the small flat head screwdriver tool to go through (see step 4 - E115206).
		Cut the water shedder for access to the upper liftgate release latch. The latch located inside the panel behind the water shedder as shown in step 5- E115207.
		Using a small flat screwdriver, insert through the hole in the water shedder and push the lever inside the latch to open the upper liftgate (see step 6 - E115208 and step - 7 E115209).
		Alternatively, you can loosen the bolts and position the actuator for access to the cable that connects to the actuator arm. Spread the plastic away from the metal bracket and grab the cable with long needle nose pliers. Pull the cable towards the actuator and the liftgate will open.

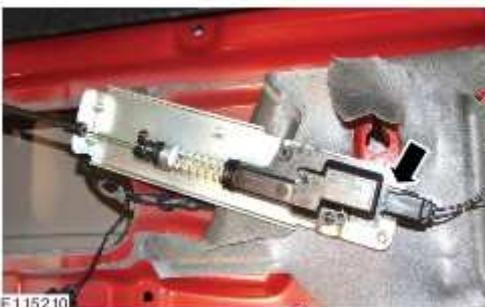
8 . Reconnect Electrical Connector.

After the upper liftgate is open, remove the carpet trim completely, follow instruction in GTR section 501-05 (76.49.23) on how to do this.
		Remove Latch and Actuator (see GTR section 501-14 (76.37.19 and 86.26.27)).
		Reconnect electrical connector to actuator as in step 8- E115210. Press external release button and check for movement of the actuator and latch.
Actuator fails to respond.	Confirm signal is sent to actuator.	If actuator does not respond, press the release button and check for signal at the electrical connector. If no signal is received, check external release switch to ensure it is functioning

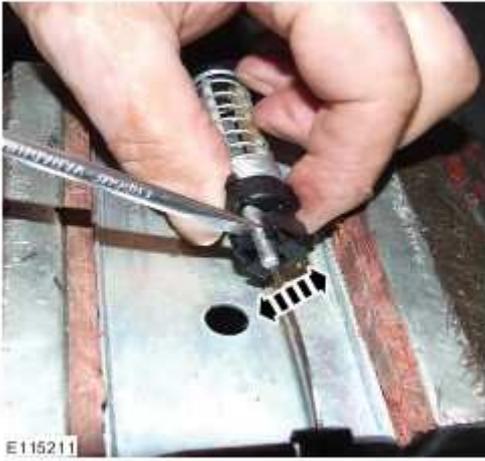
9 . Replace Actuator Assembly.

and replace if necessary.
		If a signal is received but the actuator does not respond, replace actuator assembly (see GTR section 501-14 (86.26.27)). Care must be taken when removing the latch cable from the actuator to ensure that the clip is not damaged (see step 9 - E115211 and step 10 - E115212).
		Upon completion of the actuator replacement, refit remaining components and test. The water shedder (part number EOT500013) should also be replaced before the liftgate trim is refitted.
Actuator functions but latch does not respond.	Visually inspect latch and cable end fitting.	Remove actuator cover (if fitted) and visually inspect latch and latch cable.
	Cable has become detached from actuator.	If the cable has become detached, refit the cable and secure with a cable tie. Care must be taken to ensure that the cable is fully secured and that the plastic clips on the actuator are not damaged during the procedure (see step 11- E115213 and step 12 - E115214).

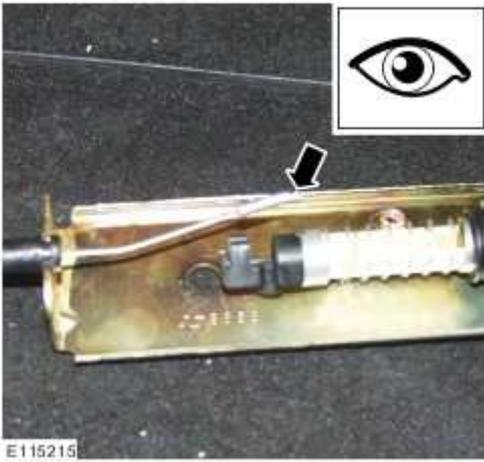
13 . Check Cable End.

Cable end fitting is damaged or has broken.	If the cable end fitting has broken, as in step 13 - E115215, only the latch should be replaced (see GTR section 501-14 (76.37.19)).
		Upon completion of the latch replacement, refit remaining components and test. The water shedder (part number EOT500013) should also be replaced before the tailgate trim is refitted.
